# Manhole Inspection Summary

Manhole # S11CC2010MH

Insp Date: **7/28/06 10:21 AM**

**Location** Address: **5805 DALE RD**

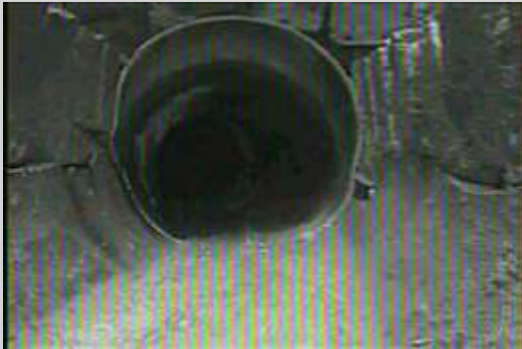
### 10 in. Circular Gravity Sewer Pipe Out @ 12 O'Clock

Pipe Material: **Unknown**

☒ Pipe Lined

Infiltration: **None**

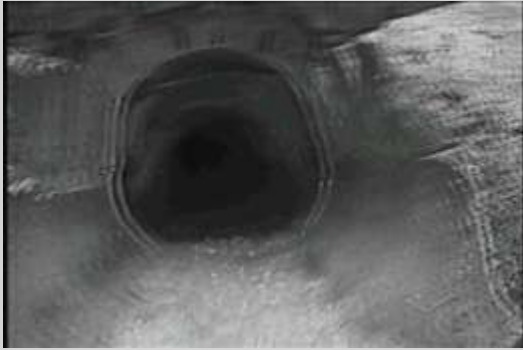
### 10 in. Circular Gravity Sewer

Pipe Material: **Unknown**

Infiltration: **None**
